Final Report

A Detailed Failure Analysis of the Ball Bearings

From a Model 1631 Tape Recorder

New Hampshire Ball Bearings, Inc.

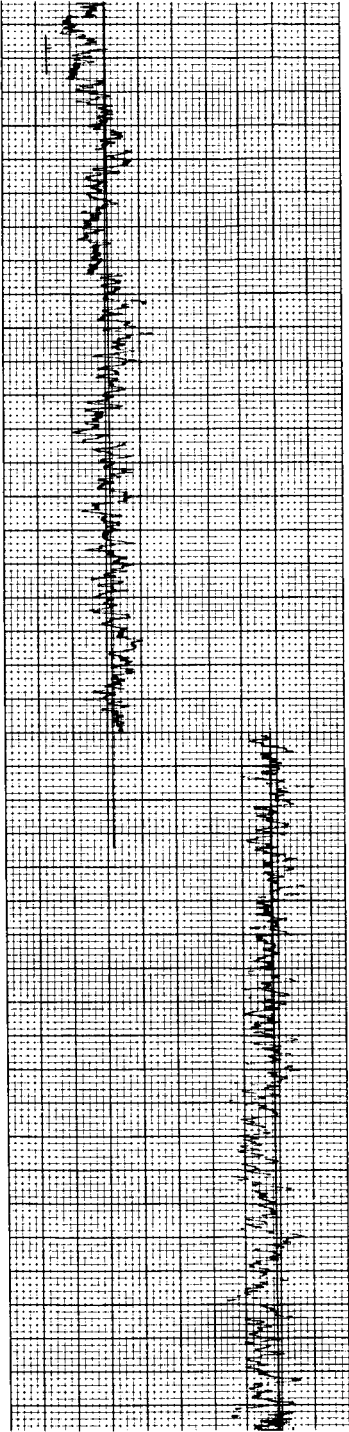
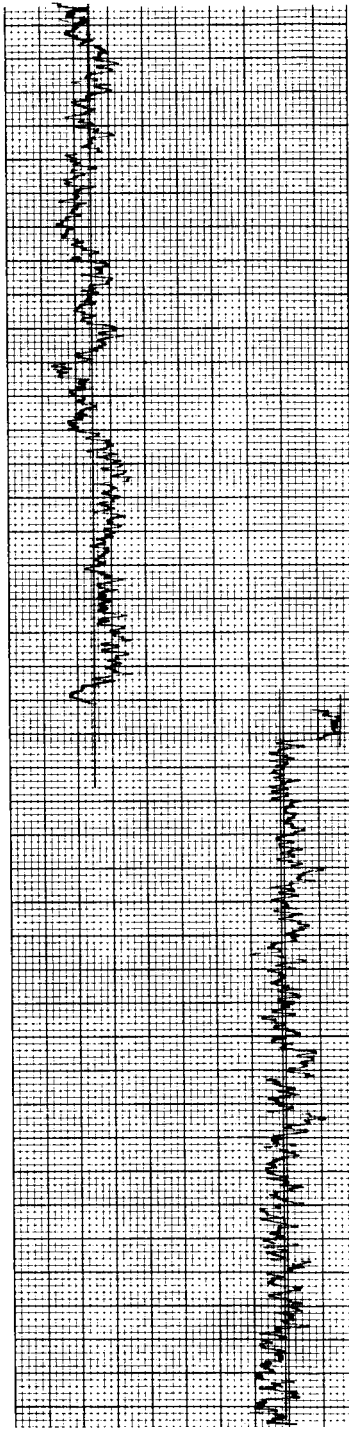
LWR 61G SPEC. 1 DATE 6/19/64 TECH IAS

ATTENUATION SET. X10		ATTENUATION SET. X10		ATTENUATION SET.	
LOAD 400	gram	LOAD 400	gram	LOAD	gram
ART 23,000	mgm	ART 27,000	mgm	ART	mgm
MRT 40,000	mgm	MRT 45,000	mgm	MRT	mgm
SCALE 2000		SCALE 2000		SCALE	
mgm/div.		mgm/div		mgm/div	
HASH WIDTH		HASH WIDTH		HASH WID.	
mgm		mgm		mgm

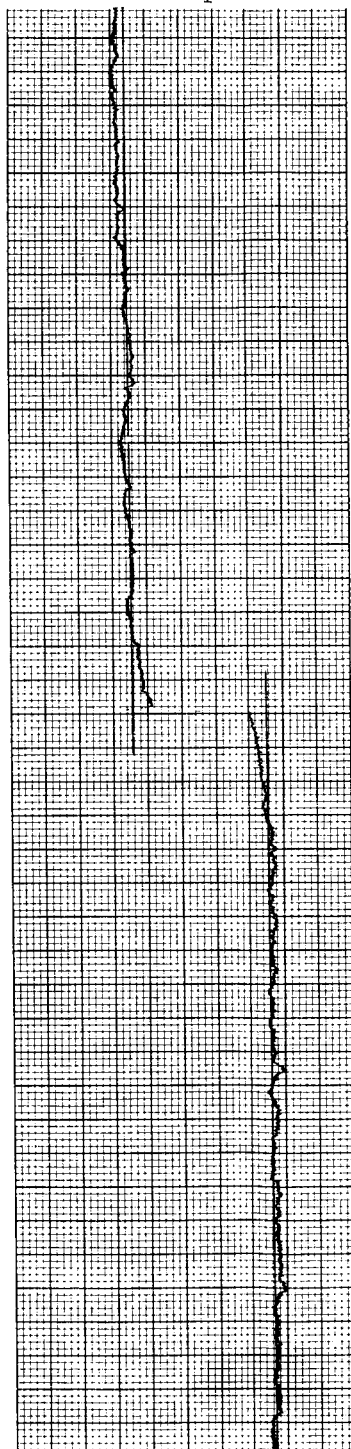
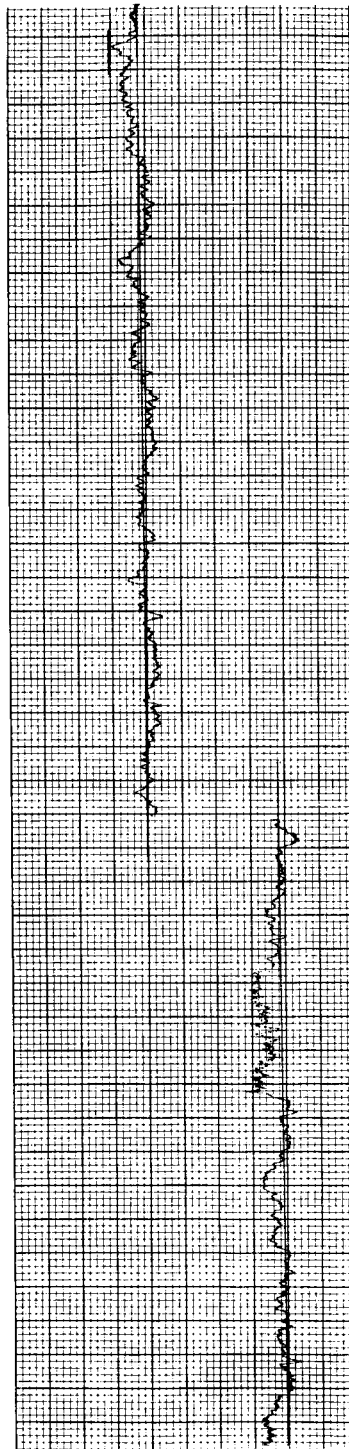
LOAD 75 gram  
ART 9,500 mgmm SCALE  
MRT 13,500 mgmm/mgmm/div  
HASH WID. mgmm

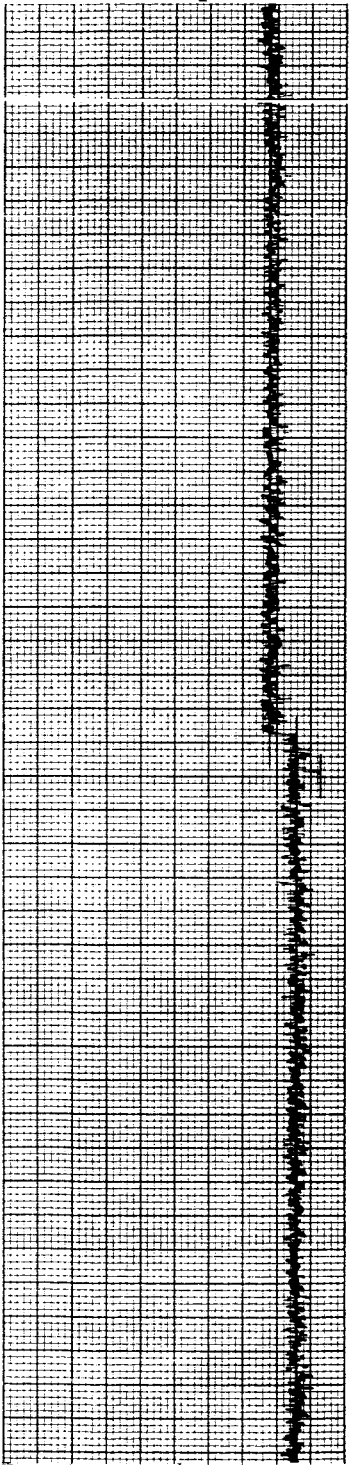
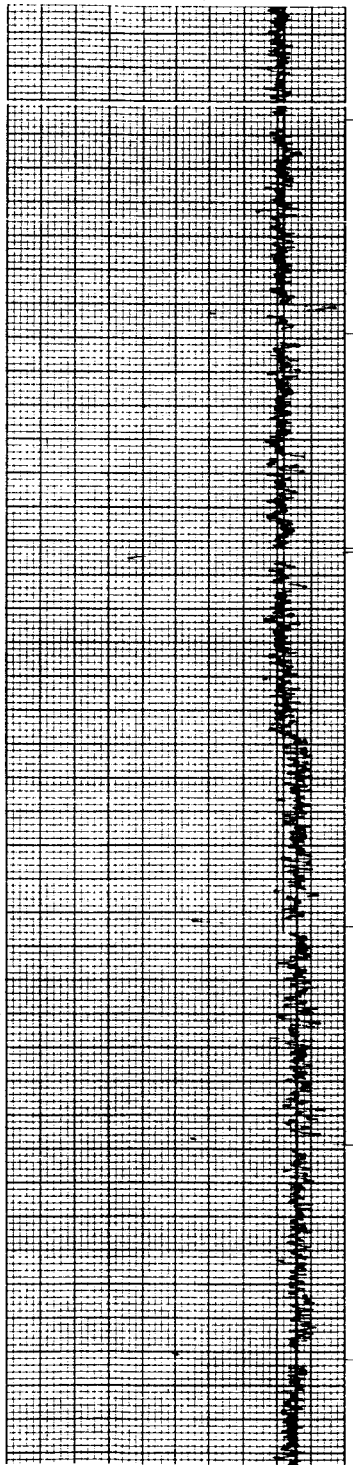
NEW HAMPSHIRE BALL BEARINGS, INC. ENGINEERING DEPT. LIFE TEST AUTOPSY REPORT										Pg.				
LWR		61G		SPEC.		3		DATE		6/19/64	TECH	IAS		
MIL-STD-206						MIL-STD-206						Smooth Ears up Ears down	Dwell	Count
After Wash Ears Up						After Wash Ears Down

MIL-STD-206	
ATTENUATION SET. X1						ATTENUATION SET. X1						ATTENUATION SET.		
LOAD	75	gram	200	LOAD	75	gram	200	LOAD		gram		SCALE		
ART	400	mgmm	SCALE	ART	200	mgmm	SCALE	ART		mgmm		SCALE		
MRT	1100	mgmm	mgmm/div.	MRT	7400	mgmm	mgmm/div.	MRT		mgmm		mgmm/div.		
HASH WIDTH			mgmm	HASH WIDTH			mgmm	HASH WID.				mgmm

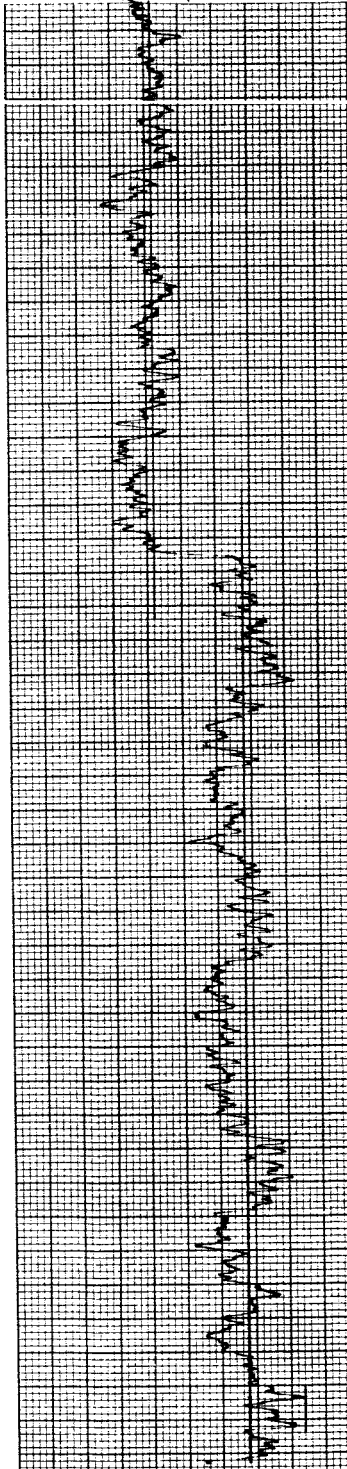
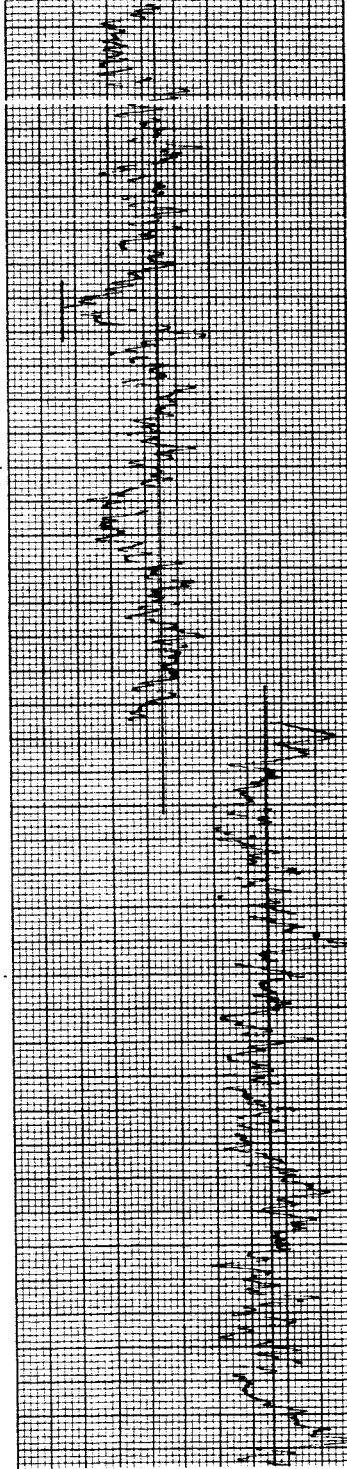
NEW HAMPSHIRE BALL BEARINGS, INC. ENGINEERING DEPT. LIFE TEST AUTOPSY REPORT										Pg.			
LWR 61G SPEC. 4		DATE 6/19/64		TECH IAS		Dwell		Count					
MIL-STD-206					MIL-STD-206					Smooth Ears up Ears down			
As Received Ears Up					As Received Ears Down

MIL-STD-206			
ATTENUATION SET. X10					ATTENUATION SET. X5					ATTENUATION SET.			
LOAD 75	gram	2000	SCALE		LOAD 75	gram	1000	SCALE		LOAD	gram	SCALE	
ART 13,000	mgm				ART 7,500	mgm				ART	mgm		
MRT 29,000	mgm	mgm/div.			MRT 21,500	mgm	mgm/div			MRT	mgm	mgm/div	
HASH WIDTH					HASH WIDTH					HASH WID.
